REINFORCEMENT USING REINFORCED CONCRETE AT THE BEGINNING OF THE 20TH CENTURY IN A SIMPLE MASONRY NEO-GOTHIC TEMPLE WITHIN A SEISMIC CONTEXT

The case study presented is the Church of Santa Filomena, a characteristic example of the neo-Gothic temples of simple brick masonry in Santiago, which, due to the Talca earthquake of 1928 (MMI 8.3), was reinforced by horizontal reinforced concrete confinement elements. Since its reinforcement, the structure has faced at least five earthquakes of over 8.0. This study seeks to answer the following question: Would the structure have had a

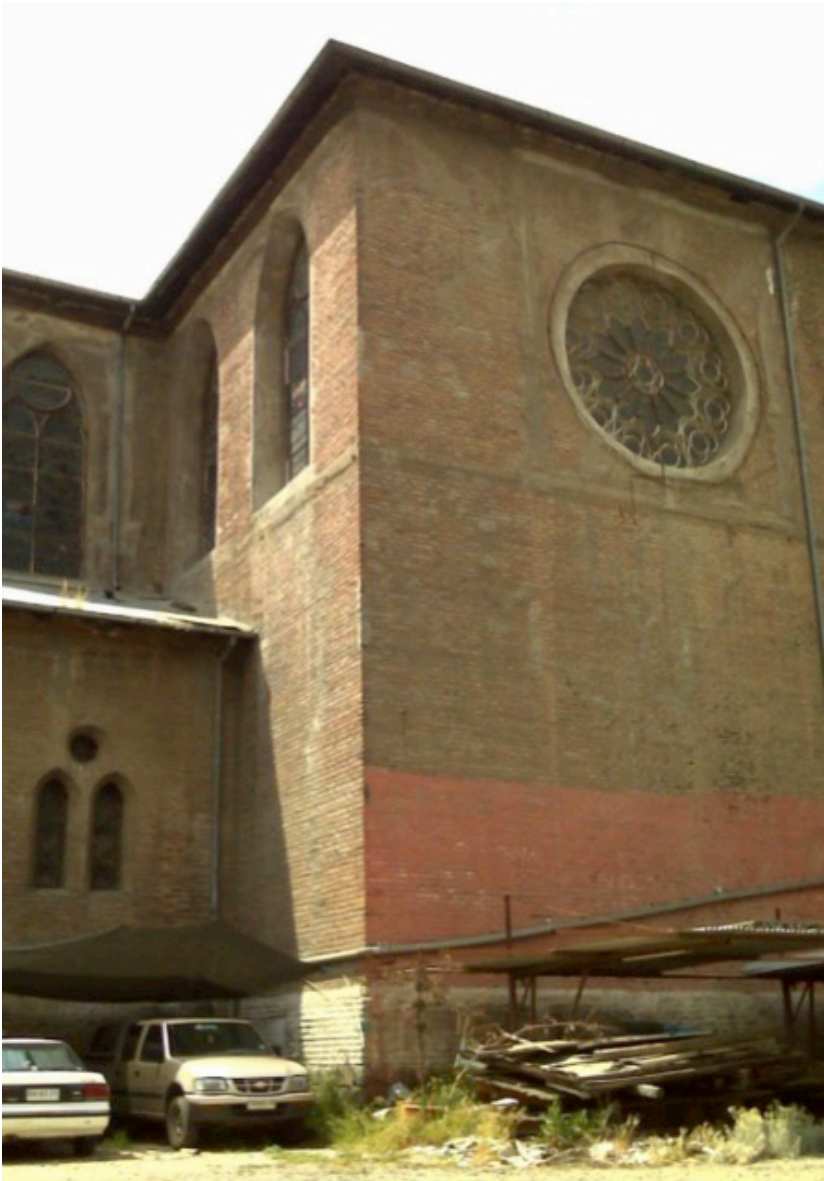
Figure 6. Reinforced concrete reinforcements in west transept.
Source: National Monuments Council [CMN] (2008).

In Figure 11 and Figure 12, the damage to the church's apse before the Maule earthquake in 2010 can be compared with the current state. It is observed that damage has reappeared in the keys of the arches and vertical fissures in the meeting of walls, which coincides with areas that were intervened prior to 2010. Similarly, if one compares the vertical fissures under the rose windows in the transept walls in Figures 6 and 8, these fissures have remained stable even after the earthquakes.

the structure was reinforced by reinforced concrete elements. This reinforcement consisted of confining the rose windows using a concrete frame formed by two chains and two pillars (Figures 6 and 8). A concrete chain was arranged around the perimeter of the walls at half height and the level of the crowning (Figures 6 and 7). The thickness of the masonry walls is 70 cm, and although it is not possible to observe the depth of the confinement inside the structure, it is enough that the concrete elements cross the wall throughout its thickness. The height of the confinement elements is approximately 20 cm for the chains that run around the perimeter (Figure 7) and 50 cm for the elements of the rose windows (Figure 8). These reinforcements are symmetrical to the longitudinal axis of the structure. Since the reinforcement date in 1928, some adjoining side spaces have been added to the church, and some minor repairs were made after the 1985 earthquake but have not been reinforced.

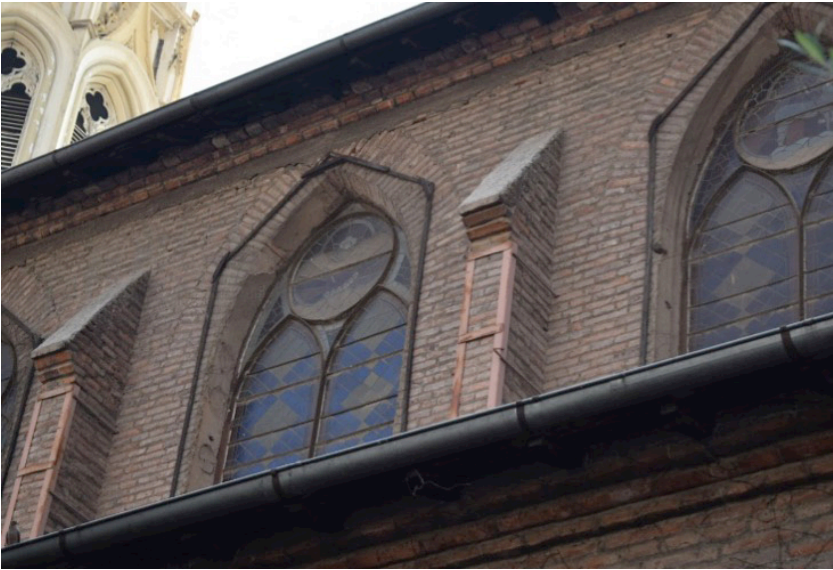
Figure 7. Reinforced concrete reinforcements crowning of the clerestory. Source: Preparation by the authors.

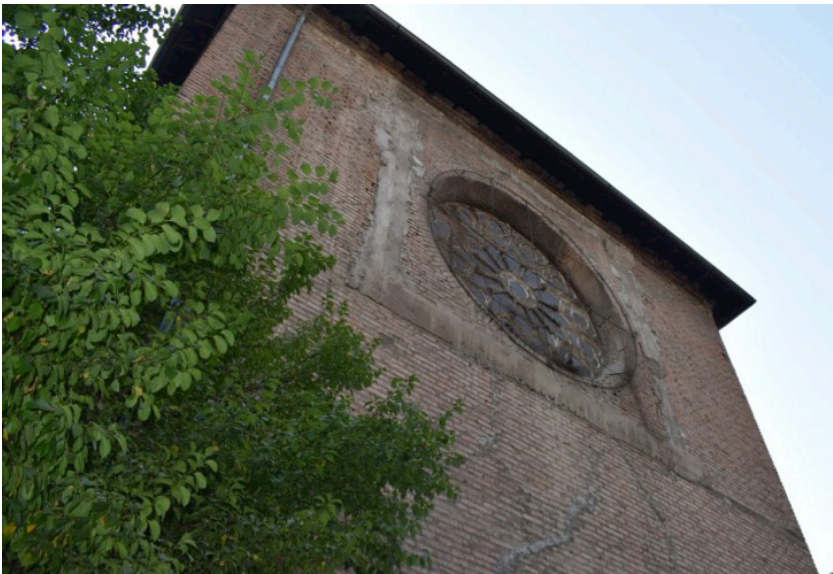
Figure 8. Reinforced concrete reinforcements in east transept. Source: Preparation by the authors.

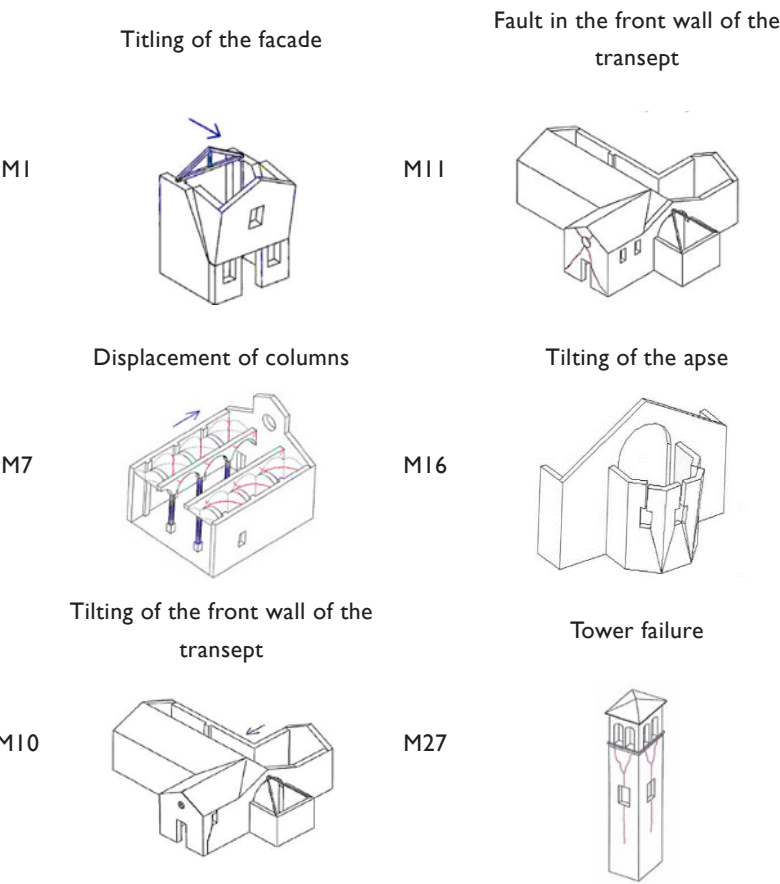
Figure 10. Collapse mechanisms observed in the church. Source: Directive of the President of the Consiglio dei Ministeri [DPCM] (2011).

behavior is not guaranteed due to the lack of confinement and the low strength of the masonry, the walls become vulnerable to out-of-plane failures (Figure 9). This is the leading cause of damage or collapse of existing masonry structures (Casapulla et al., 2017).

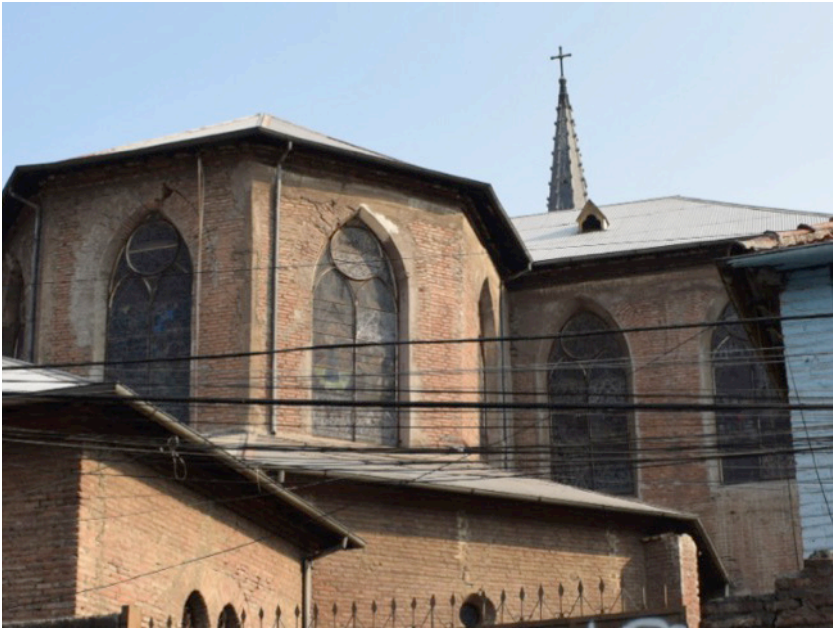
According to Hermosilla and Ortega (1995), the 1985 earthquake (Mw 8.0) produced cracks in the walls of the apse, partial collapses, cracks in the front walls, damage to the form arches,

Figure 11. State of the apse prior to the Maule earthquake (Mw 8.8). Source: National Monuments Council [CMN] (2008).

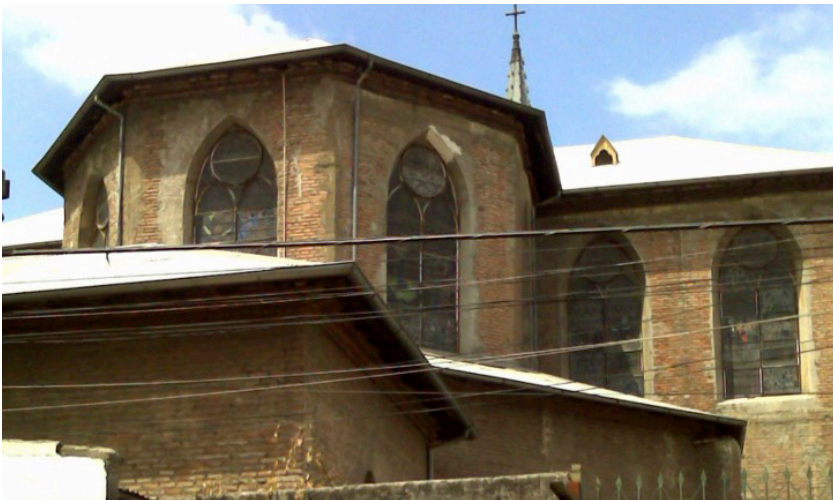
Figure 12. State of the apse after the Maule earthquake (Mw 8.8). Source: Preparation by the authors.

and bricks crumbling. Based on a survey of structural damages carried out in 2023 (Sáenz Muñoz, 2023), it was determined that the damages the structure has are moderate and from the activation of mechanisms by faults inside and outside the plane of the walls, such as: tilting of the facade, displacement of columns, tilting of the front wall of the transept, failure in the front wall of the transept, tilting of the apse and failure of the tower (Figure 10). Therefore, the damages repaired after the 1985 earthquake reappeared, possibly due to the 2010 earthquake (Mw 8.8) or the 2015 Illapel earthquake (Mw 8.4).
