Interventions at la Moneda Palace, from the 19th, 20th, and 21st centuries.

The projects and their architects

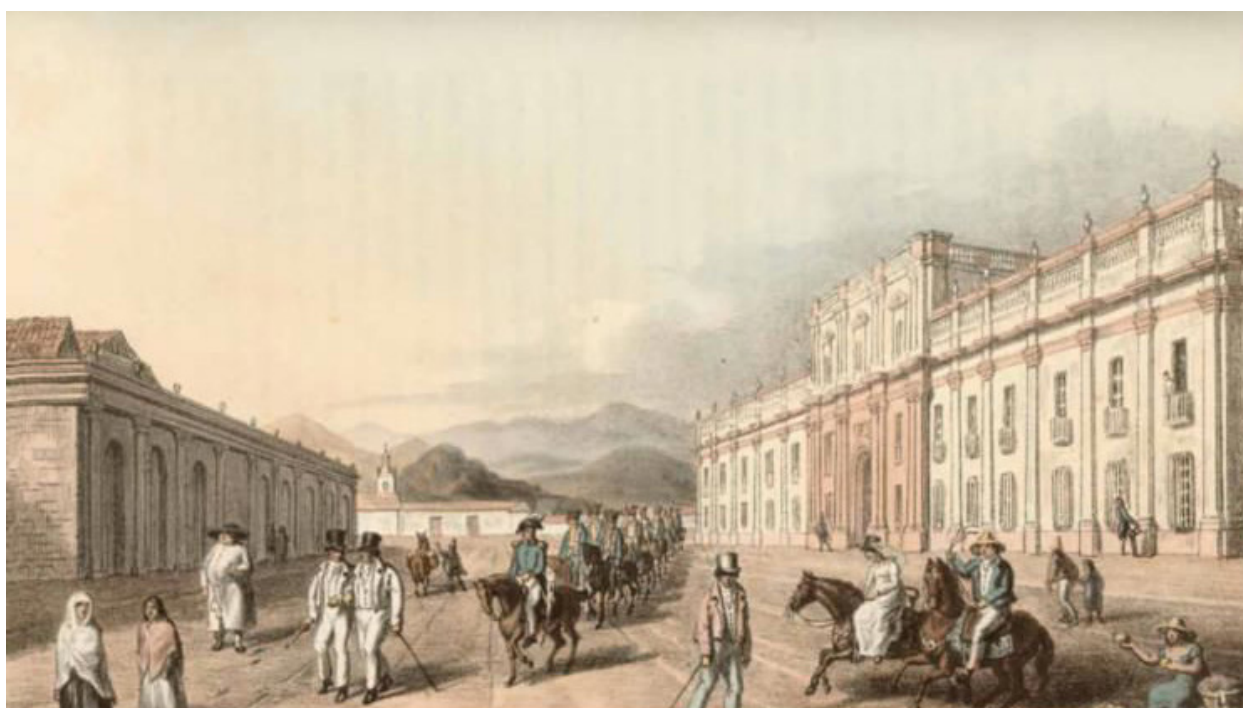
Figure 5 Perspective of Palacio de La Moneda, 1821.

Figure 5 represents one of the oldest graphic records of *Palacio de La Moneda*, where one can see what it would have been like upon its inauguration and how the main portico could have been brown, different from the classic white. It is important to mention that this image corresponds to an interpretation since it has differences in proportions with respect to reality (Castro, 2006).

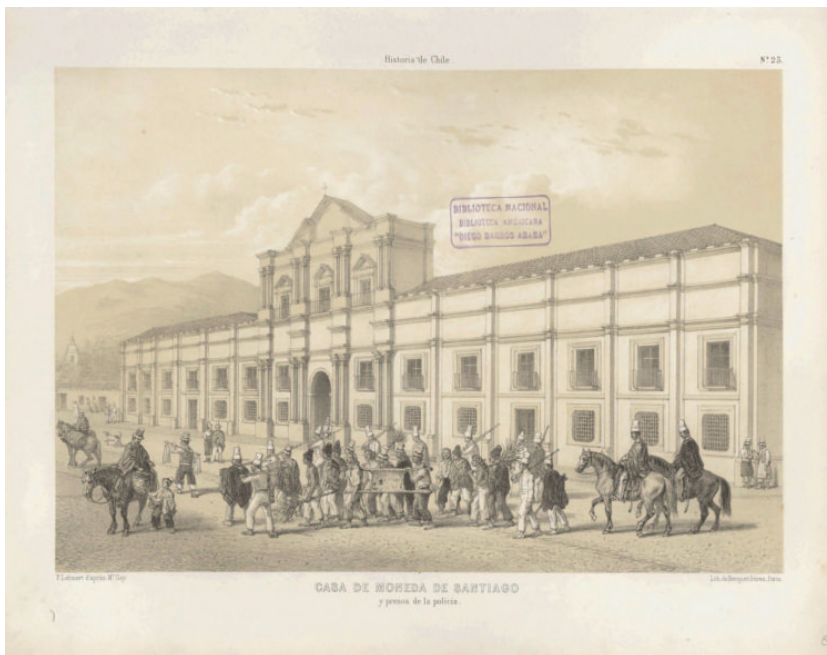
Figure 6 Mint after removing the finials, the central body's parapet, and replacing the balusters with hard boards, by Lehnert (1854).
Source: Guarda (1997, p. 203).

a telluric movement that severely affected the upper level of the building. Some of the frames and upper ornaments of the main facade fell, leading to the decision to remove the remaining elements to relieve weight and avoid future accidents, while the entire parapet structure was replaced with a wooden balustrade (Guarda, 1997).

Figure 6 outlines how *Palacio de La Moneda* evolved after the aforementioned restoration, by showing the wooden boards implemented at the top. This is the only graphic record of the building at the time, though it should be noted that does not have the correct morphology of the Palace, since it makes changes to its height and the perspective of the roof, possibly because the author was positioned at a different height when he made it (Castro, 2006).

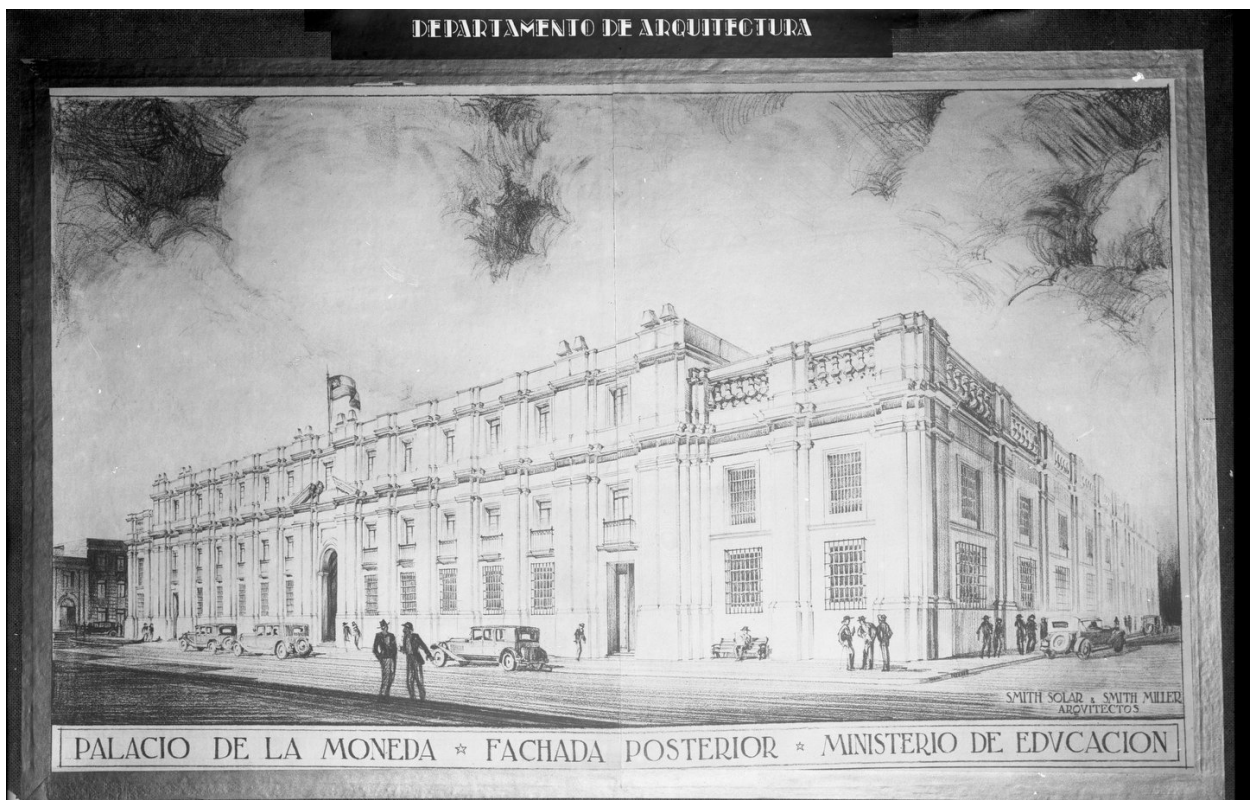
Figure 8 South facade project of Smith Solar & Smith Miller, by Josué Smith Solar (1929). Source: MOP Architecture Directorate Photographic Archive.

The architects proceeded to repeat the facades of Morandé, Teatinos, and Moneda, preserving the aesthetics outlined by Toesca (Alegría *et al.*, 1983) and, to increase capacity in the new southern body, they projected a new body with three floors, unlike the original two-level volume, subdividing it into 17 sections for greater interior fragmentation, in contrast to the 15 sections considered by the Italian (Department

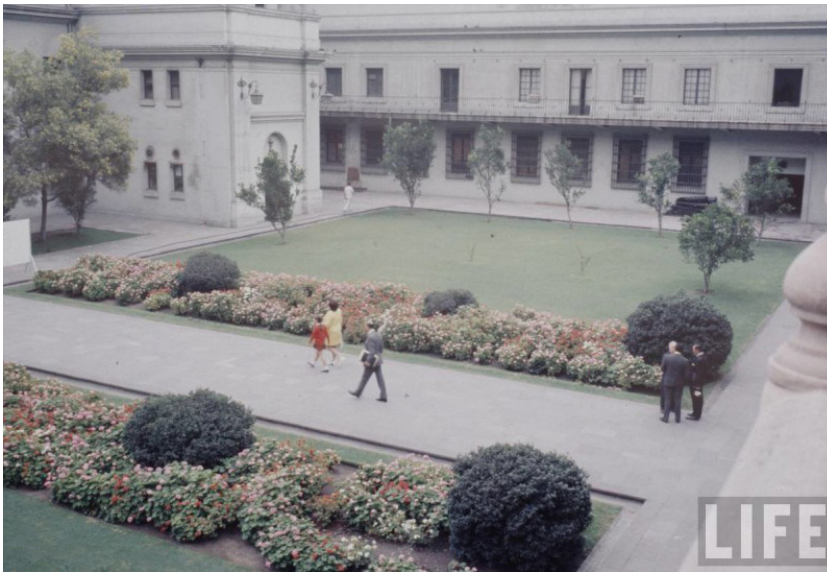
Figure 10 Photo of *Patio de los Naranjos*, by Michael Mauney (1971). Source: *Enterreno Chile* (2016).

During the mandate of President Juan Antonio Ríos, in 1940, the Minting and Balance pavilion was demolished (Figure 9) to make room for a new sector, the *Patio de Los Naranjos* (Orange Grove Courtyard) (Figure 10), which, obviously, received its name from those fruit trees. Two fragments of the building remained, which were used to support two water fountains (Alegría et al., 1983).

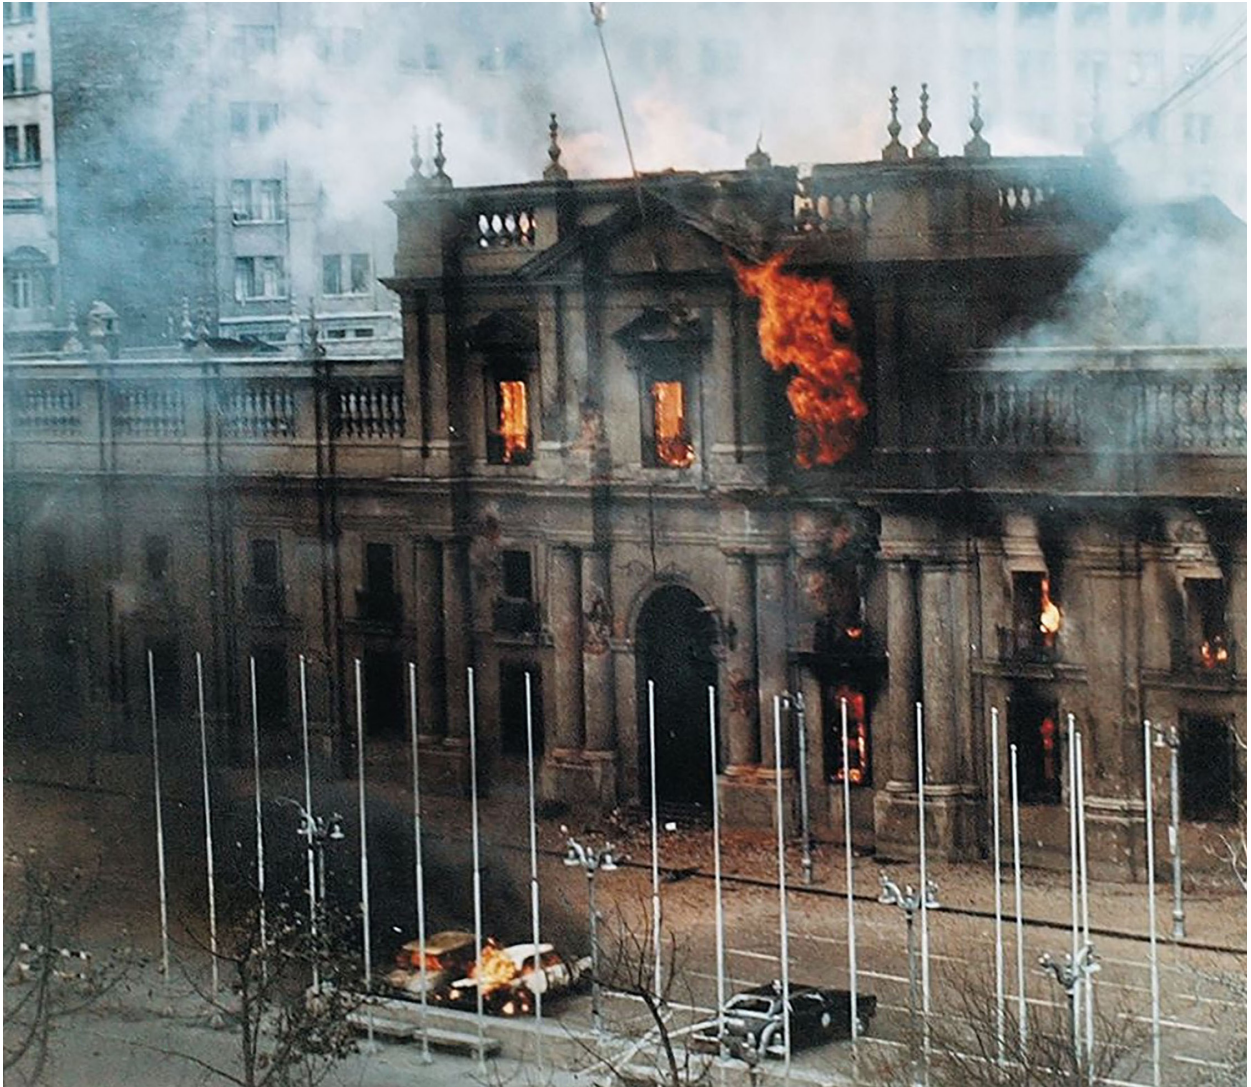
Figure 11 North façade of Palacio de La Moneda during the bombardment (1973). Source: MOP Architecture Directorate's Photograph Archive.

September 11th, 1973, saw a coup d'état organized by the Armed Forces to overthrow the government of Salvador Allende, ending democracy in Chile, and starting a dictatorship that lasted 17 years. The *Palacio de la Moneda* was hit by a six-hour bombardment, seven air strikes, and 18 Hawker Hunters missiles, which caused a fire that collapsed the earthenware of the second floor and the roof. The damage suffered by the building was so serious that some architects pointed out that only the brick walls that had been glued with lime and sand remained standing, with the exception of the southern body, made of reinforced concrete slabs, which in the end, could not resist the fire (Valencia, 2018). (Figure 11, Figure 12 and Figure 13)

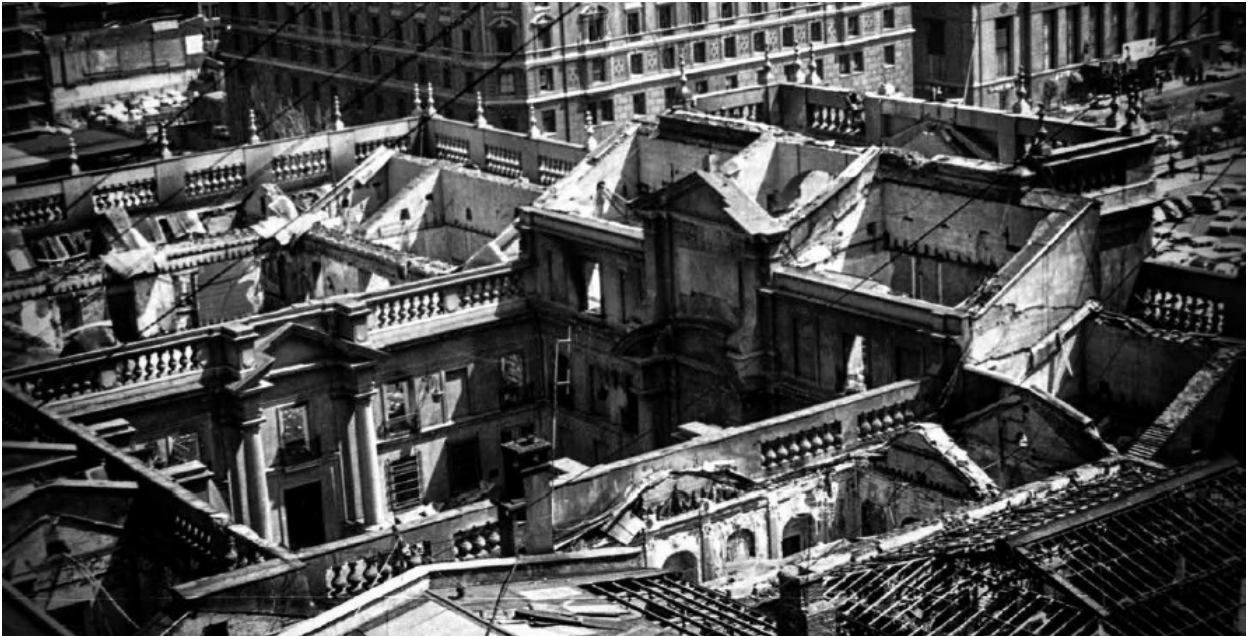
Figure 12 Overhead view of Palacio de la Moneda after the bombing, by DA MOP (1973).
Source: DARM MOP (2014).

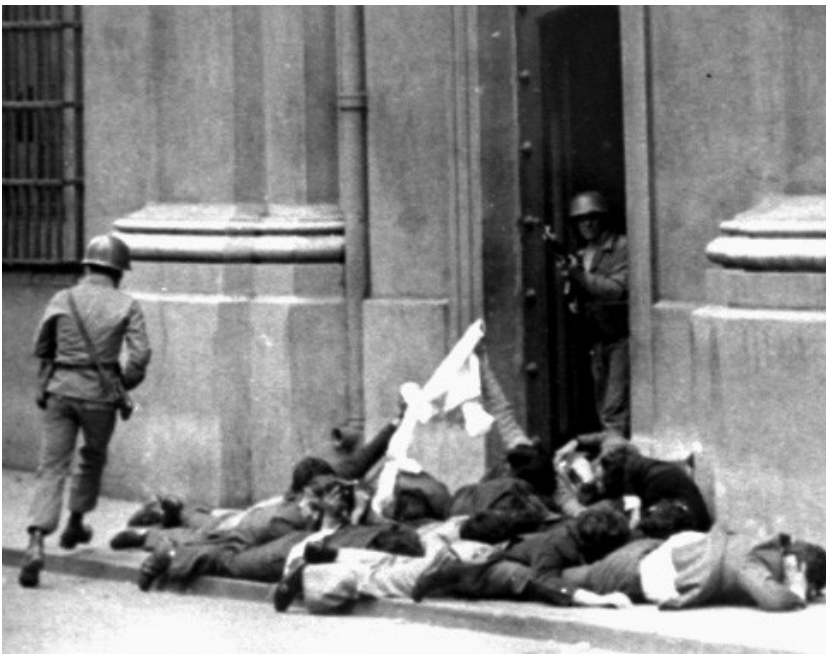
Figure 13 Morandé 80 entrance during the bombing (1973).
Source: MOP Architecture Directorate's Photograph Archive.

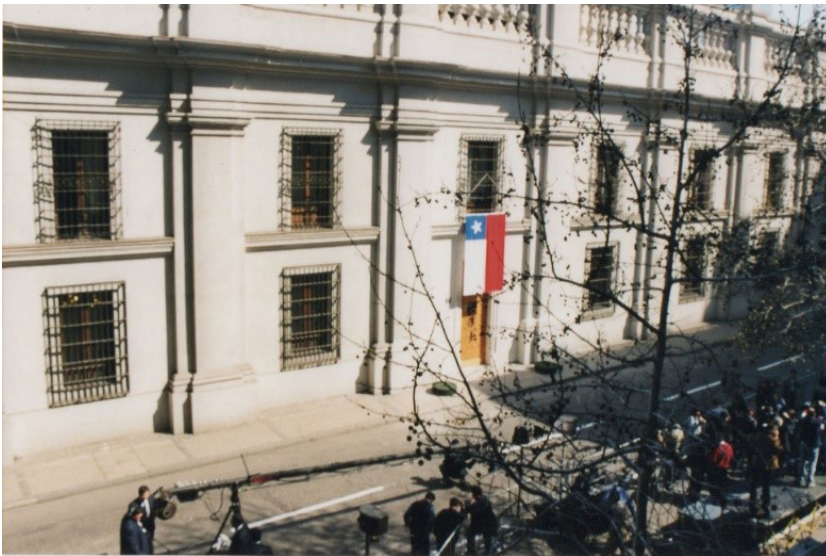
Figure 14 View of the Morandé 80 entrance (2003).
Source: Architecture Directorate's Photograph Archive.

Regarding the Morandé 80 entrance as such, it was restored to its original location, removing the window that had occupied its place since the 70s; hence, the new access does not exceed the width of the windows present on the facade in question (Figure 14). In the interior space that directly faces the door of Morandé 80, there is a commemorative plaque and a restricted guest book (Peña, 2013).

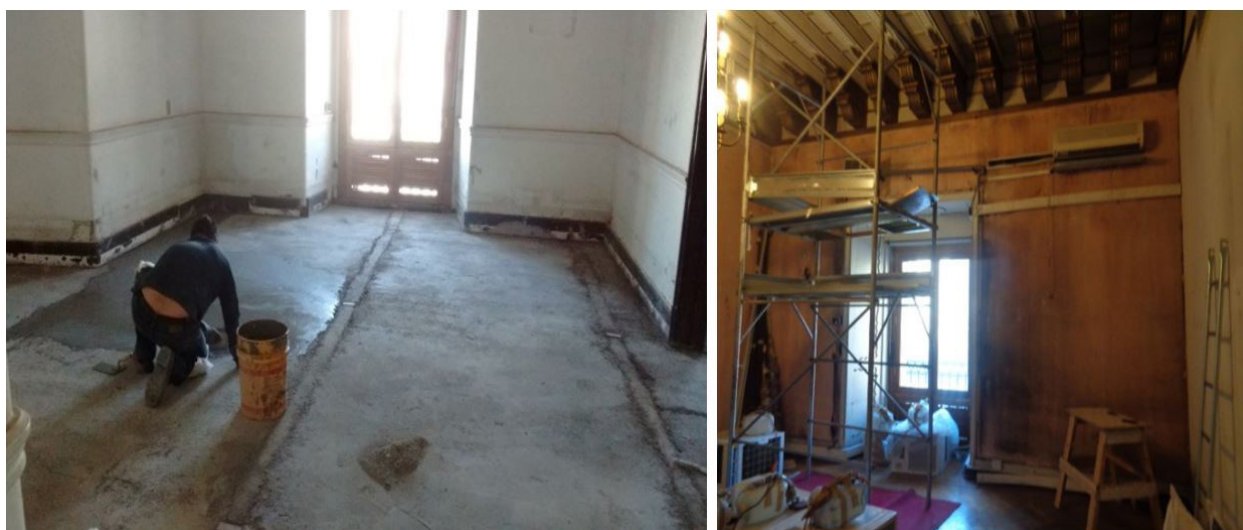
Figure 15 Conservation works
South Wing (2016 – 2018).
Source: DARM MOP (2016).

These works showed the clear deterioration of the building, both in spatial and material areas, due to a large number of isolated interventions, especially in the south wing. For the same reason, the MOP Architecture Directorate focused the conservation work, during the 2012 – 2019 period, on this part of the building. (Figure 15 and Figure 16)

The conservation works sought to free the area in question from poor workmanship and smaller-scale components added later, which altered the attributes and value of the monument. The intervened area included the offices of the Ministry of the Interior, the Undersecretariat of Regional and Administrative Development, and the General

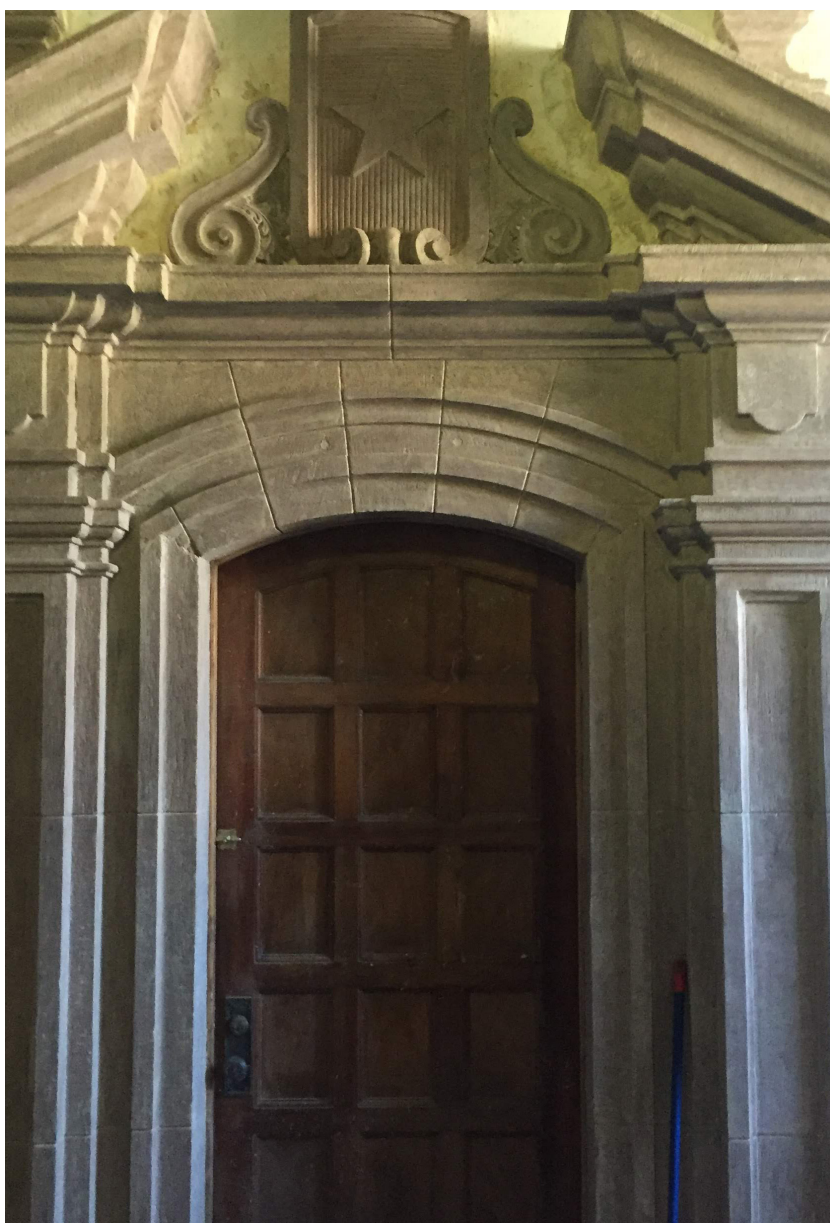
Figure 16 Cleaning of interior
doors' stone frames. Source:
DARM MOP (2016).
