Daniel Málaga-Montoya

DOCUMENTING REPUBLICAN ARCHITECTURE IN AREQUIPA. SPATIAL, CONSTRUCTIVE, AND STYLISTIC ASSESSMENT OF THREE EMBLEMATIC "CASONAS"

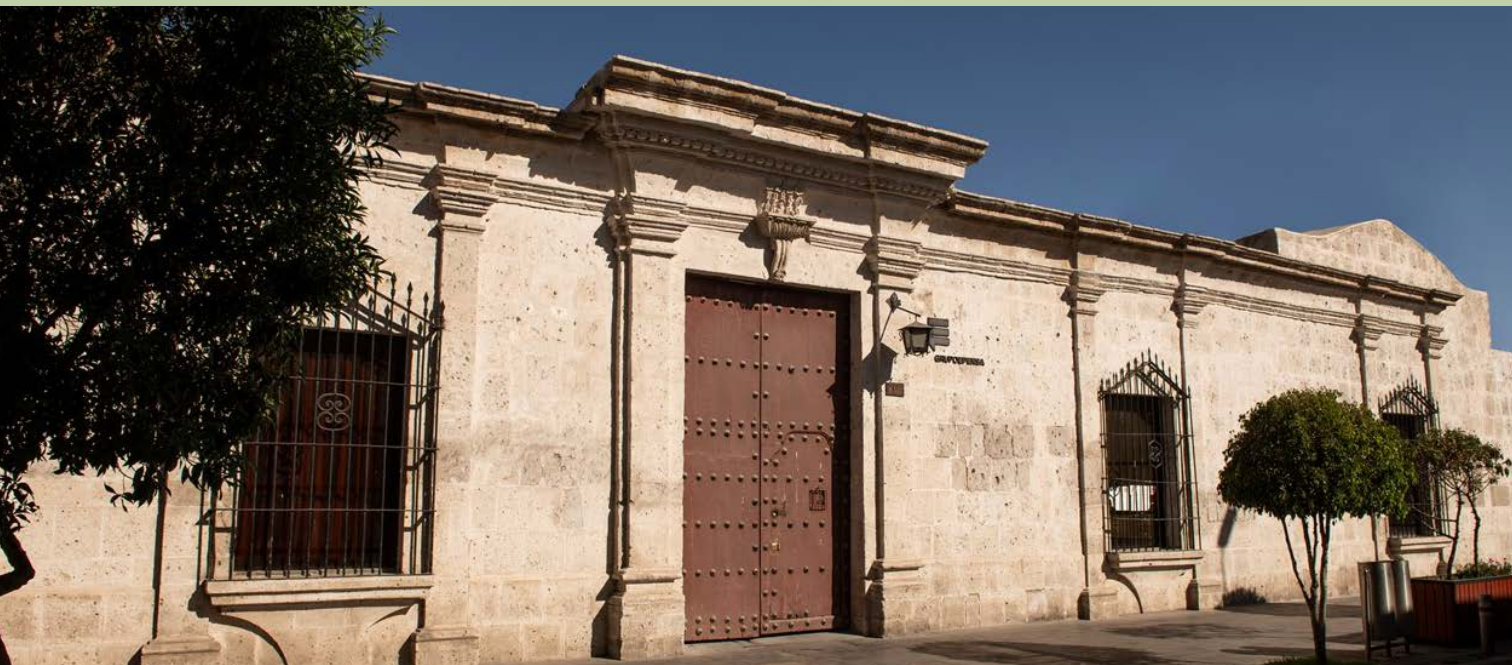
Figura 0. Inventario fotográfico
obtenido Alianza Francesa.
Fuente: Elaboración de los
autores.

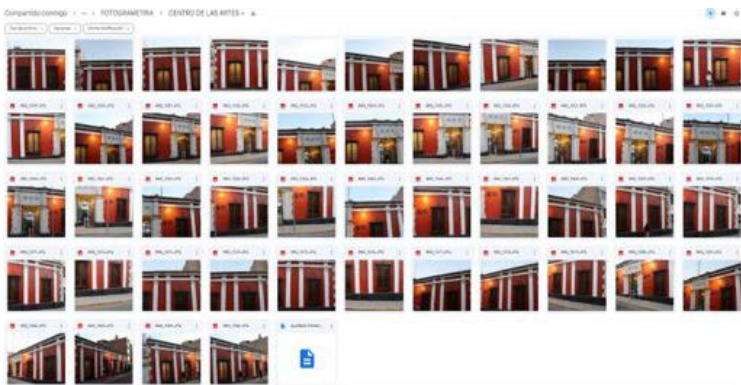
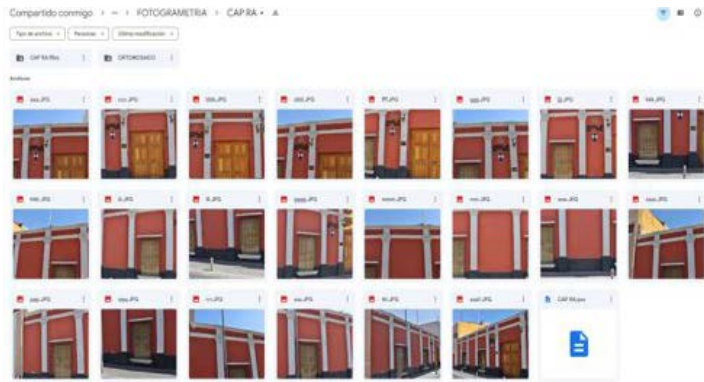
Figure 1. Photographic inventory obtained for the photogrammetric processing of the case studies. (a) Alianza Francesa (b) UCSP Arts Center (c) College of Architects CAP-RA. Source: Preparation by the authors.

The photographic survey consisted of taking data from sequenced photographs of the exterior and interior facades of the building. The photographic survey shots were taken using mass data capture techniques with a Canon DS12676I Professional Camera -and tripod. The image survey process was conducted on the exteriors of the houses based on close-up object shots.

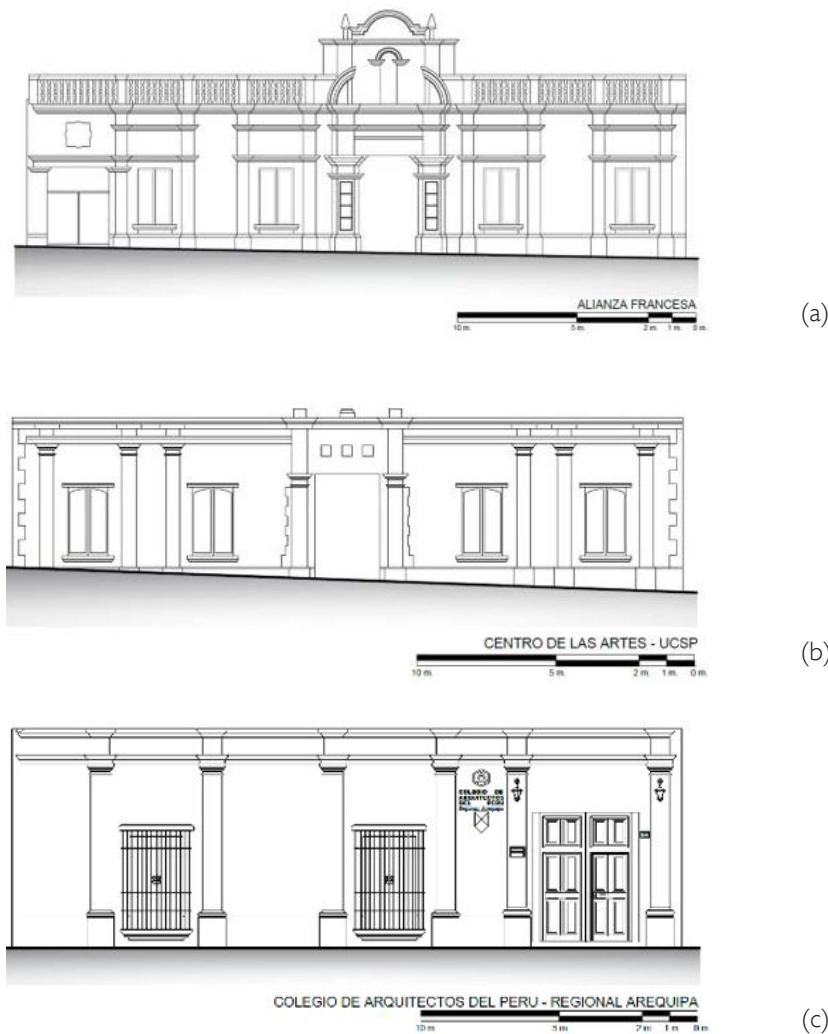
Figure 3. Redrawing the facades of the case studies. (a) Alianza Francesa (b) UCSP Arts Center (c) College of Architects CAP-RA. Source: Preparation by the authors.

A 2D redrawing was made in AutoCAD using the orthophotos obtained, obtaining accurate and detailed elevations of the case studies' main facades. This result was an invaluable tool for the comparative analysis of the main formal components.

For this analysis, the elevations of the buildings shown by photogrammetry and redrawn in 2D were used, identifying the following components:
