DOCUMENTING REPUBLICAN ARCHITECTURE IN AREQUIPA. SPATIAL, CONSTRUCTIVE, AND STYLISTIC ASSESSMENT OF THREE EMBLEMATIC "CASONAS"

DOCUMENTANDO LA ARQUITECTURA REPUBLICANA DE AREQUIPA. VALORACIÓN ESPACIAL, CONSTRUCTIVA Y ESTILÍSTICA DE TRES CASONAS EMBLEMATICAS

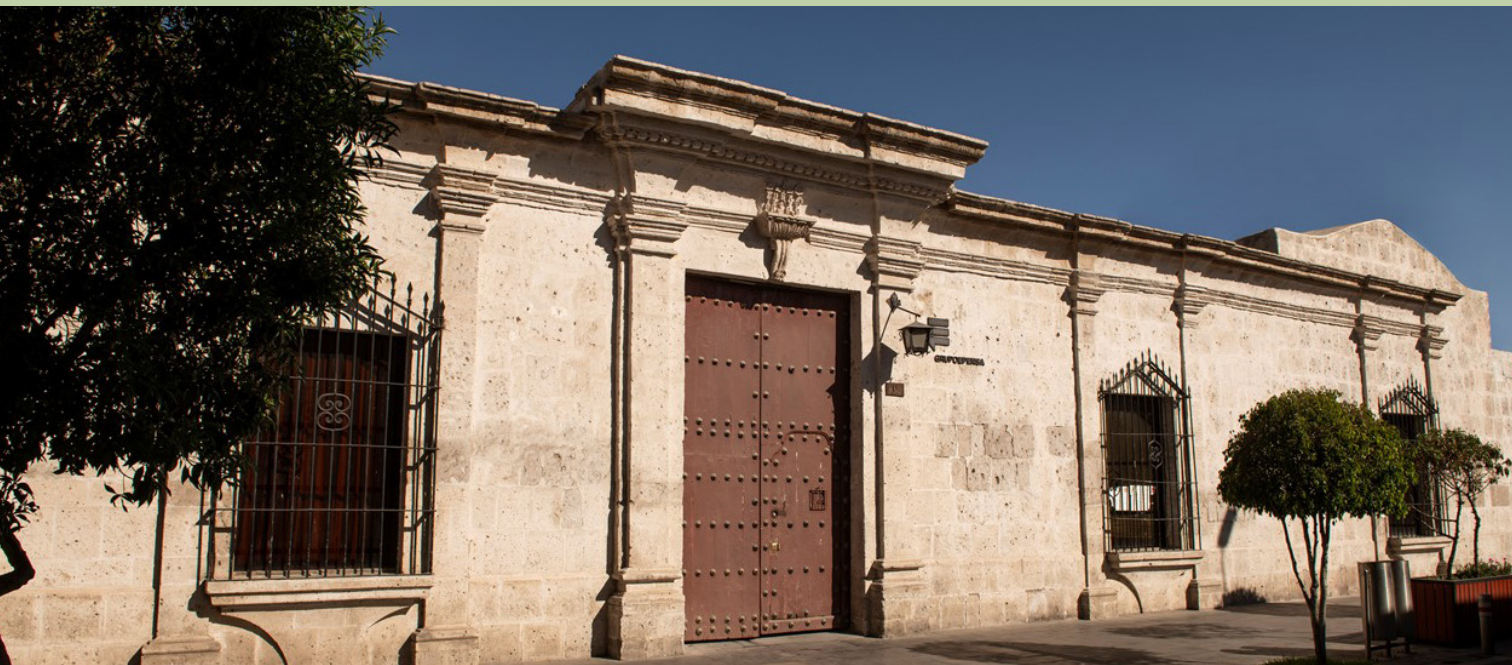
Figure 0. Photographic
inventory obtained Alianza
Francesa. Source: Preparation by
the authors.

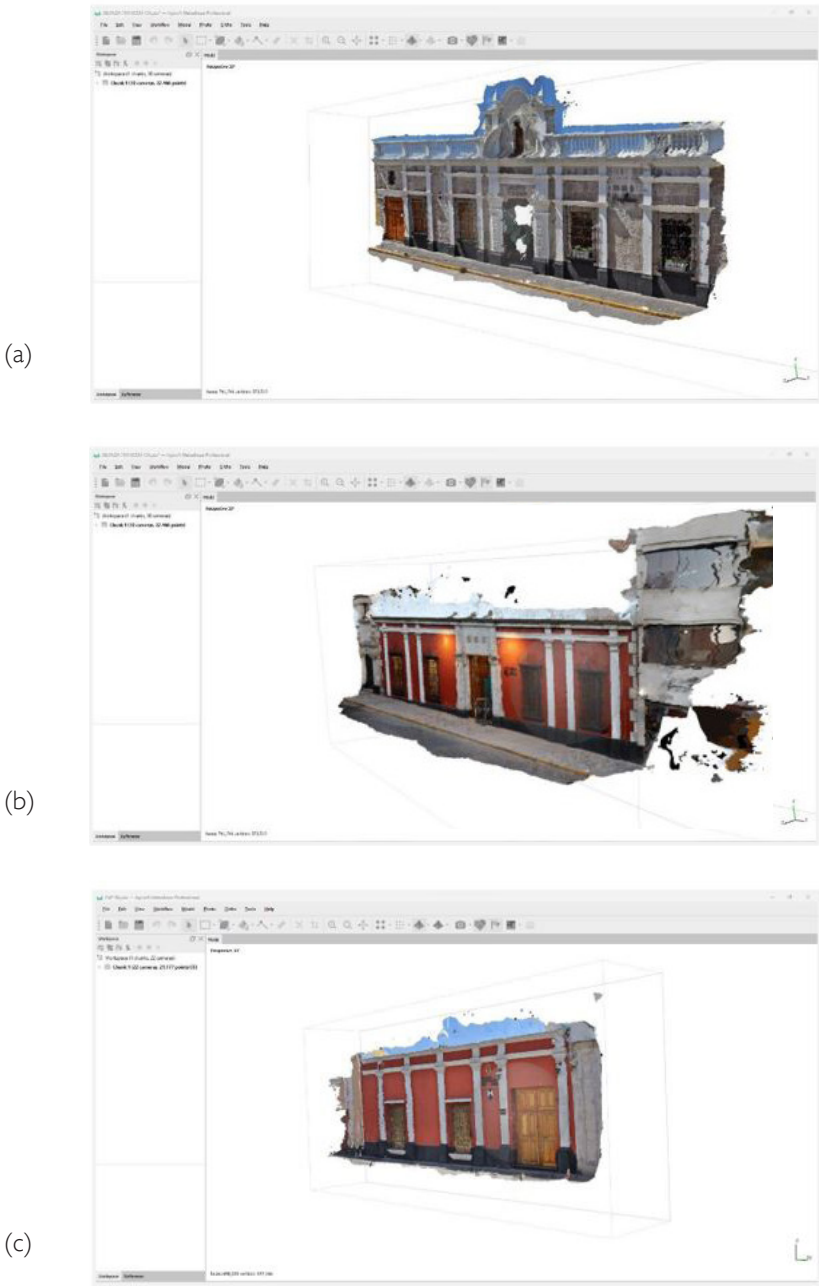
Figure 2. 3D models obtained from the photogrammetric survey. (a) Alianza Francesa (b) UCSP Arts Center (c) College of Architects CAP-RA. Source: Preparation by the authors.

The graphic data was processed in the Metashape software from Agisoft, where the images are integrated to achieve point clouds that are concatenated to form polygons that result in a three-dimensional model (Figure 2). By applying this technique, it is possible to conserve the original details. One hundred photographs were taken at 7:00 am for CAP-RA, 1:00 pm for Alianza Francesa, and 5:00 pm for the UCSP Arts Center. An average of 30 photos per building were documented, with an image capture period of 10 to 15 minutes per facade. The images obtained constituted a reference catalog for

the subsequent analysis and processing of information for the diagnosis to be performed. The 2D and 3D models allowed comparison of the case studies' spatial, constructive, and stylistic evolution data.

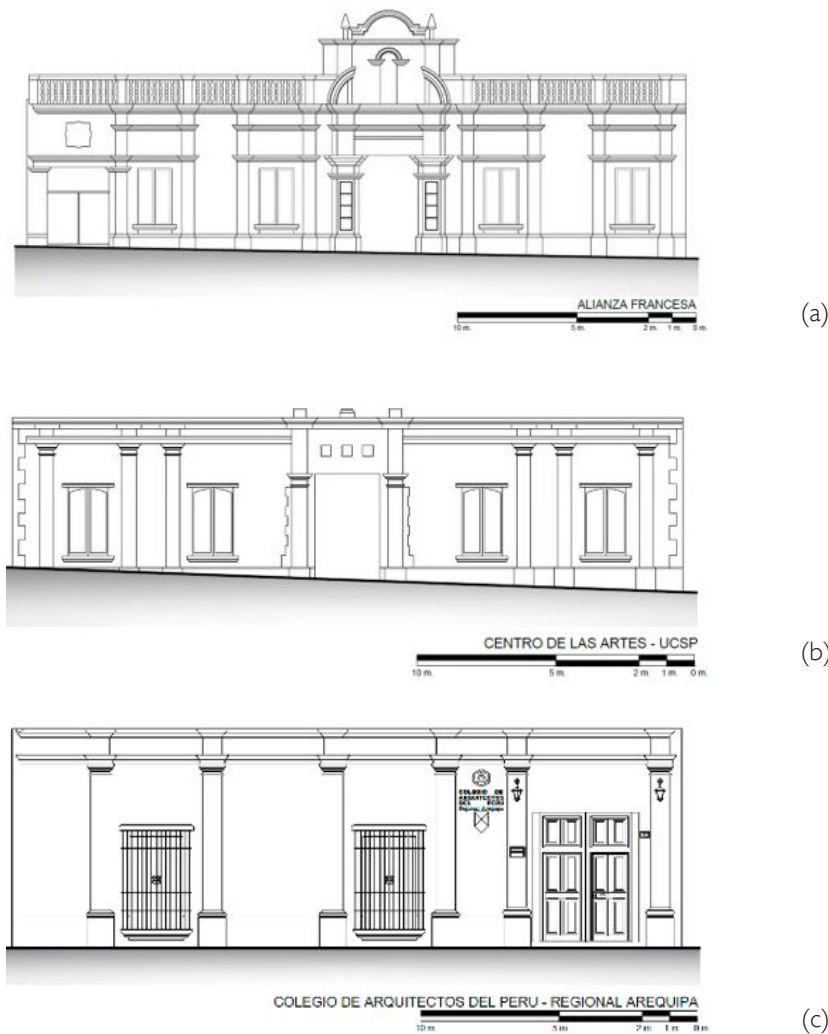
Figure 3. Redrawing the facades of the case studies. (a) Alianza Francesa (b) UCSP Arts Center (c) College of Architects CAP-RA. Source: Preparation by the authors.

A 2D redrawing was made in AutoCAD using the orthophotos obtained, obtaining accurate and detailed elevations of the case studies' main facades (Figure 3). This result was an invaluable tool for the comparative analysis of the main formal components.
