Effects of design configuration on decay initiation and progression in non-durable wood

Abstract:

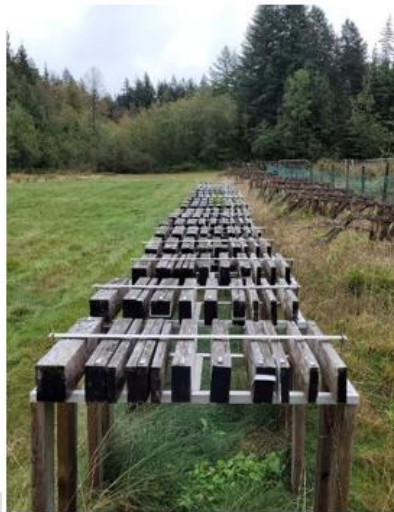
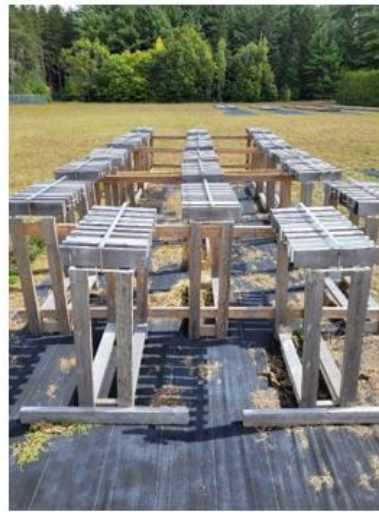
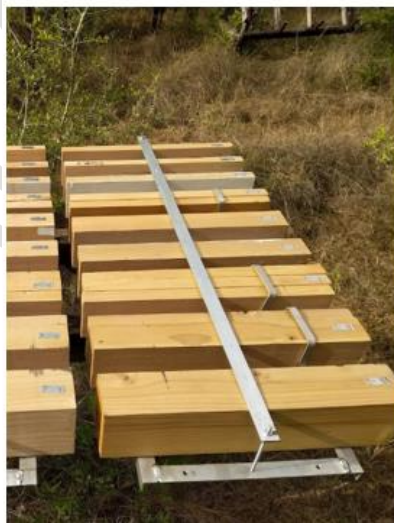
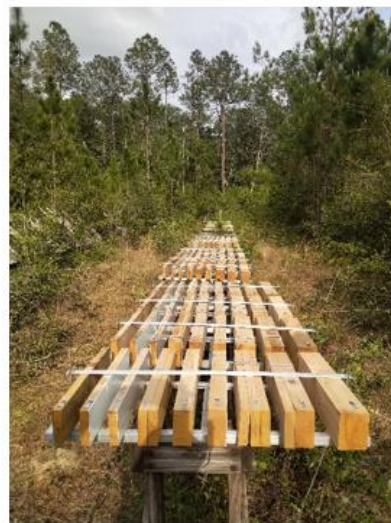
Test materials were installed on aluminum frames approximately 1 m above the ground. Specimens had holes drilled on the underside of either end and sat fitted atop bolts protruding upward from the frame. All specimens were oriented on edge. Contact with the frame was limited to two points near either end of the specimen. In configurations with appressed boards the gap between boards was vertical to create a water trap. An aluminum bar was placed above each rack of specimens to hold each unit in place without touching the specimens (Figure 1).

Figure 1: Design configuration test specimens in Petawawa, Ontario (top left) and Maple Ridge, British Columbia (top right) after exposure, Saucier, Mississippi (lower left) at time of installation, and close up to show the rack design (lower right).

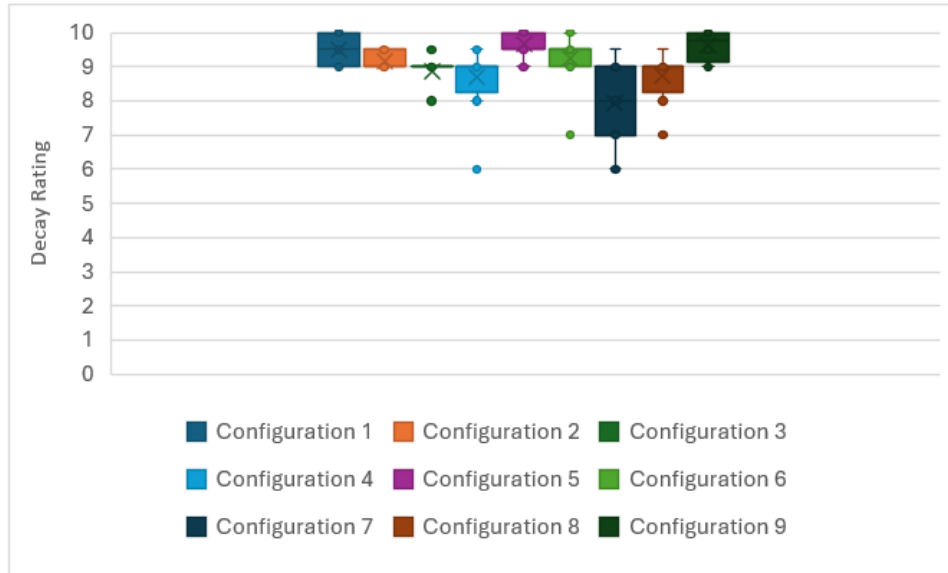
To understand the impact of design configuration on extent of decay at selected times, box and whisker plots were prepared for each figuration at each site. These included the 72-month data from Petawawa and Maple Ridge, and the 36- and 58-month data from Saucier (Figure 6, Figure 7, Figure 8, Figure 9). Similar trends were observed at all sites, with extent of decay greatest in configurations 3, 4, 7 and 8. This corresponds with the clipped board configurations and the configuration which had two coated sides.

Figure 6: Box and whisker plot for 72-month decay ratings for each configuration in Petawawa, Ontario.

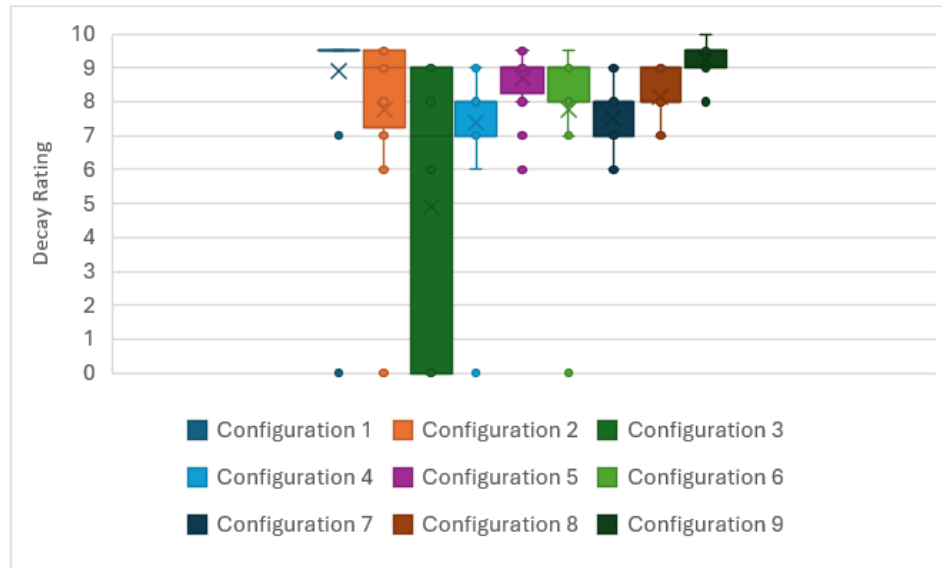
Figure 8: Box and whisker plot for 36-month decay ratings for each configuration in Saucier, Mississippi.
