## Density based resistance model for structural assessment of timber elements using inspection data\*

### Abstract:

### **The case study of Maloca**

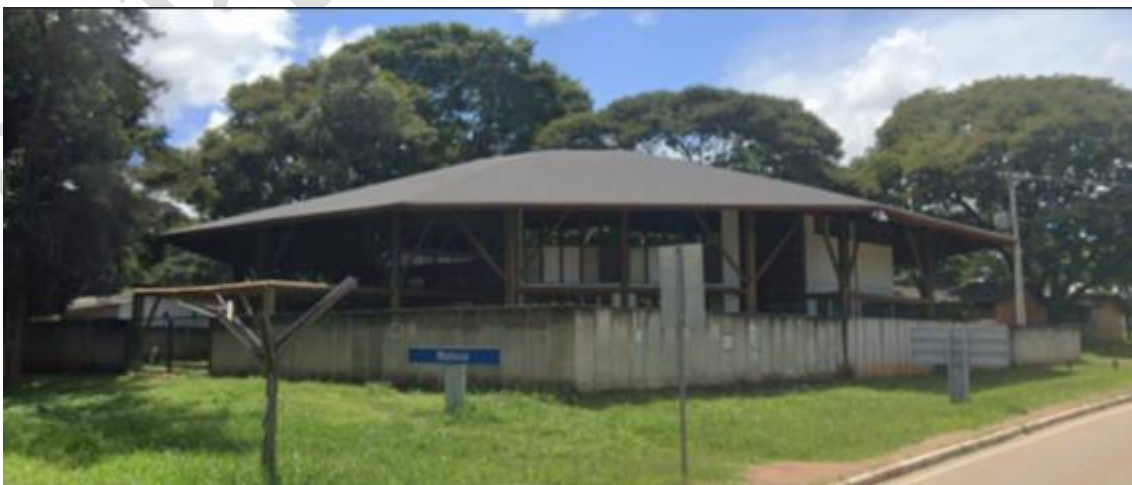
A case study will be carried out at the Maloca of the University of Brasília. The Maloca is a two-story building whose structure is made entirely of round eucalyptus wood. The building is shown in Figure 1.

**Figure 1:** Front facade of the Maloca (Laboratório de Reabilitação do Ambiente Construído 2022).

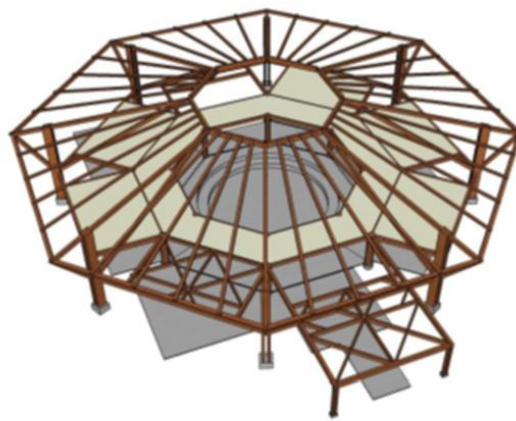
**Figure 2:** Isometric view of the structural design of the Maloca (Laboratório de Reabilitação do Ambiente Construído 2022).

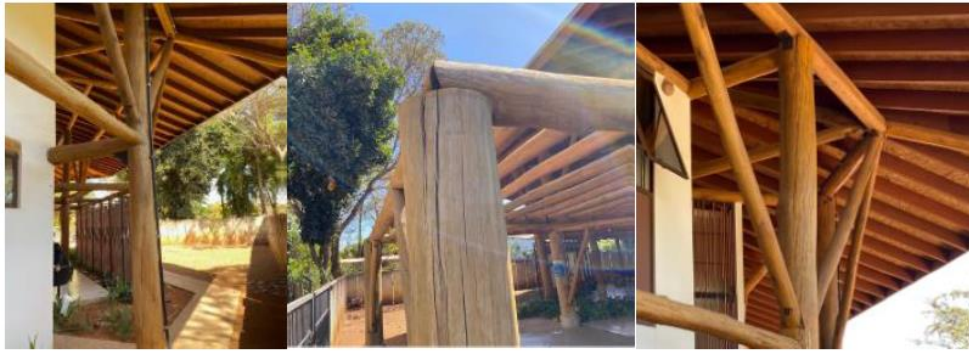
Figure 3 shows photos of some of the columns of the Maloca taken during the inspection.

**Figure 3:** Photos taken of the Maloca's columns (Laboratório de Reabilitação do Ambiente Construído 2022).

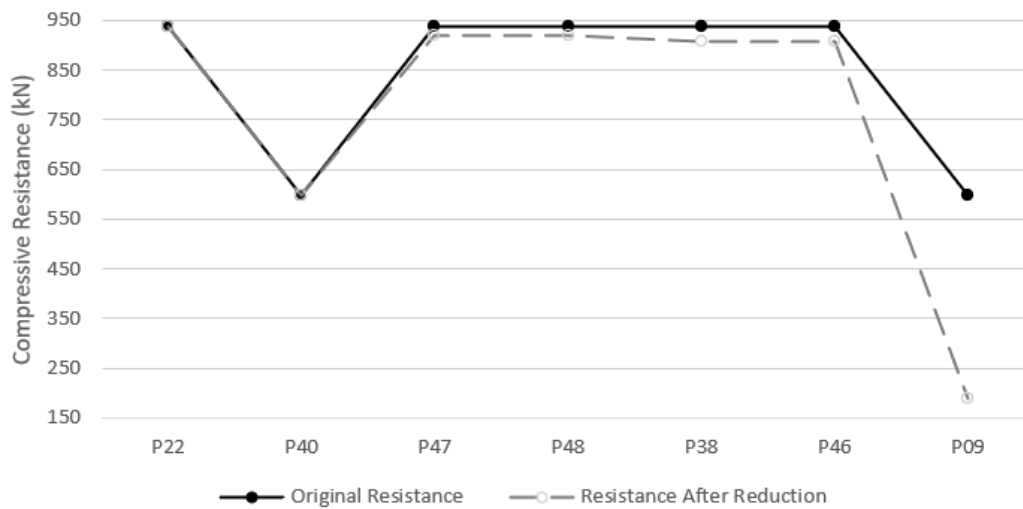
Table 6 and Figure 5 present the final values found for the compressive resistance of the columns before and after reducing the basic density based on the degradation factors.

**Figure 5:** Compressive resistance values for the columns.

The element with the greatest loss of resistance was Column P09, with a 68,51 % reduction. Since it is a crucial structural element for the stability and safety of the structure, immediate and urgent intervention and maintenance are recommended.

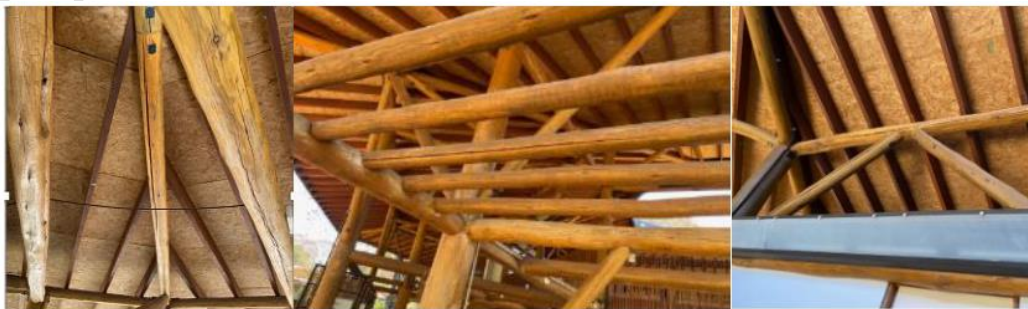
Figure 6 shows photos of some of the beams of the Maloca taken during the inspection.

**Figure 6:** Photos taken of the Maloca's beams (Laboratório de Reabilitação do Ambiente Construído 2022).

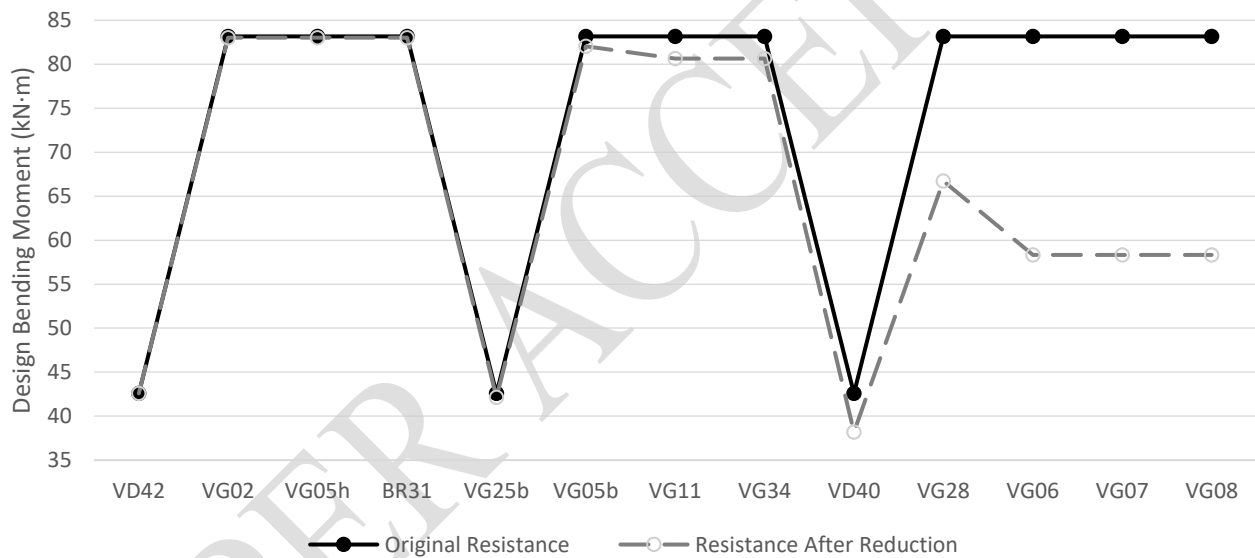
Table 9 and Figure 8 present the final values found for the design bending moment for simple straight bending of the beams, before and after the reduction of basic density based on the degradation factors.

**Figure 8:** Bending moment values for simple straight bending of the beams.

Regarding the beams, elements VG06, VG07, and VG08 showed the greatest resistance losses, with reductions of 29,88 % in bending and 26,26 % in shear. Given these significant reductions - close to 1/3 and 1/4, respectively - these elements should also be prioritized for urgent intervention.

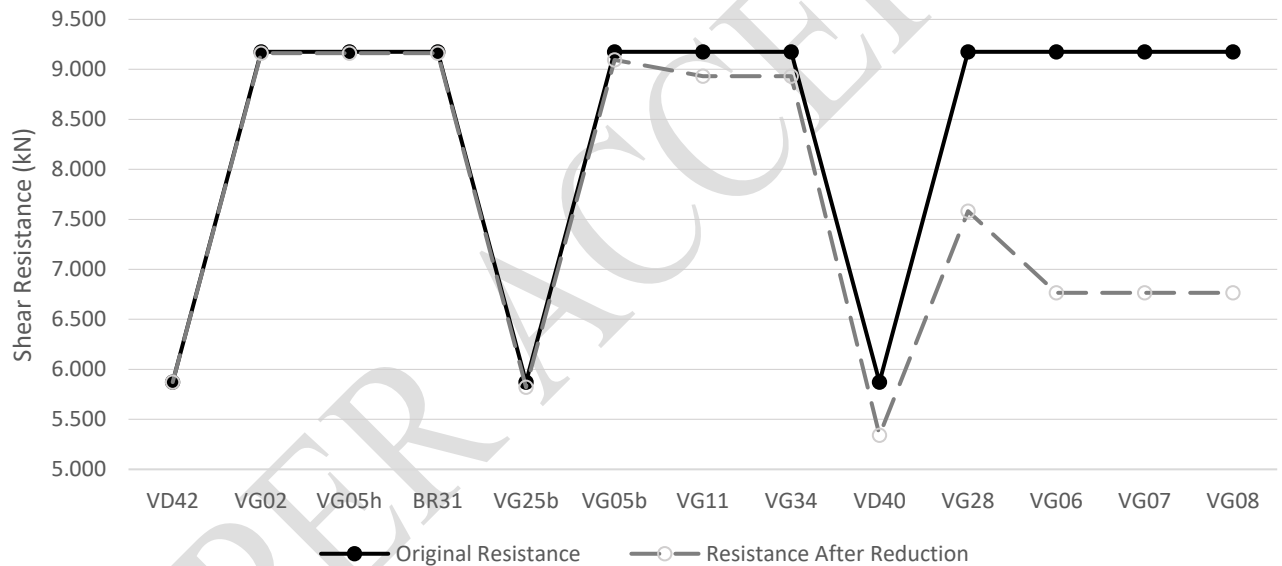
Table 11 and Figure 10 present the final values found for the shear resistance of the beams, before and after the reduction of basic density based on the degradation factors.

**Figure 10:** Shear resistance values for the beams.

Additionally, it can be observed that the relative losses in shear resistance were smaller, percentagewise, than those in simple bending resistance. This suggests that, in the event of failure of these structures, the collapse mechanism would likely involve the rupture of the wood fibers along the longitudinal direction of the beams.
