REINFORCEMENT USING REINFORCED CONCRETE AT THE BEGINNING OF THE 20TH CENTURY IN A SIMPLE MASONRY NEO-GOTHIC TEMPLE WITHIN A SEISMIC CONTEXT

The case study presented is the Church of Santa Filomena, a characteristic example of the neo-Gothic temples of simple brick masonry in Santiago, which, due to the Talca earthquake of 1928 (MMI 8.3), was reinforced by horizontal reinforced concrete confinement elements. Since its reinforcement, the structure has faced at least five earthquakes of over 8.0. This study seeks to answer the following question: Would the structure have had a

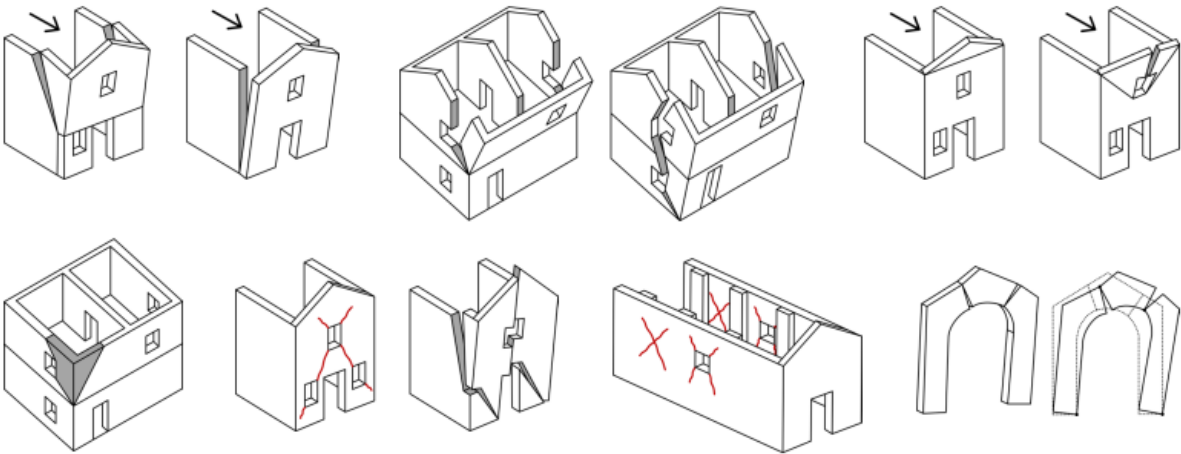
Figure 9. Examples of collapse mechanisms in masonry structures. Source: Directive of the President of the Consiglio dei Ministeri [DPCM] (2011).

behavior is not guaranteed due to the lack of confinement and the low strength of the masonry, the walls become vulnerable to out-of-plane failures (Figure 9). This is the leading cause of damage or collapse of existing masonry structures (Casapulla et al., 2017).
