# DENSITY BASED RESISTANCE MODEL FOR STRUCTURAL ASSESSMENT OF TIMBER ELEMENTS USING INSPECTION DATA\*

### The case study of Maloca

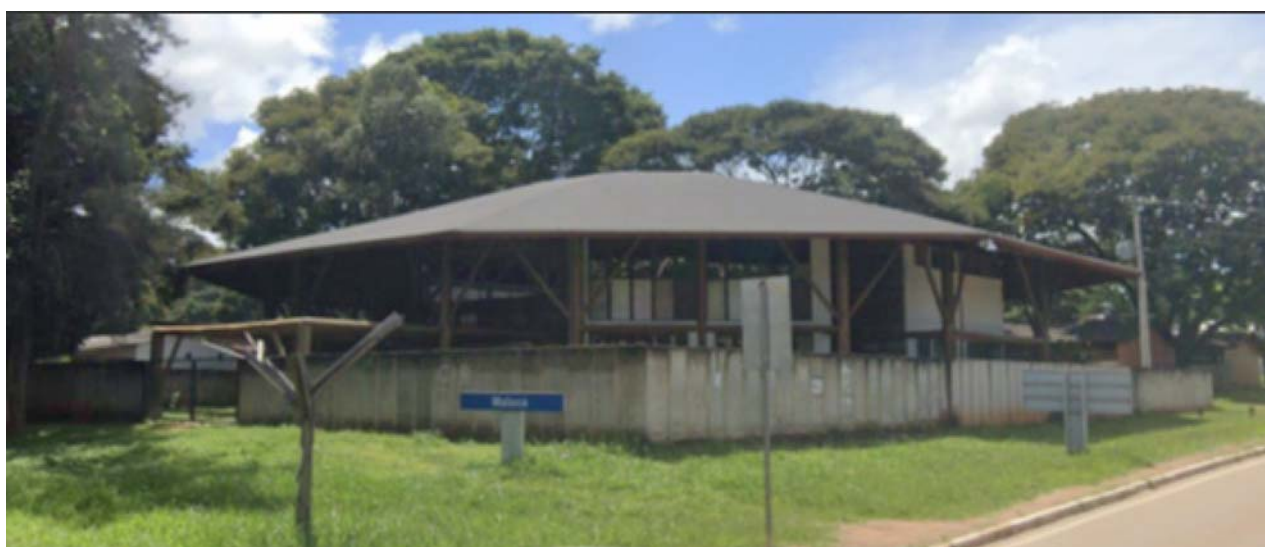
A case study will be carried out at the Maloca of the University of Brasília. The Maloca is a two-story building whose structure is made entirely of round eucalyptus wood. The building is shown in Figure 1.

**Figure 1:** Front facade of the Maloca (Laboratório de Reabilitação do Ambiente Construído 2022).

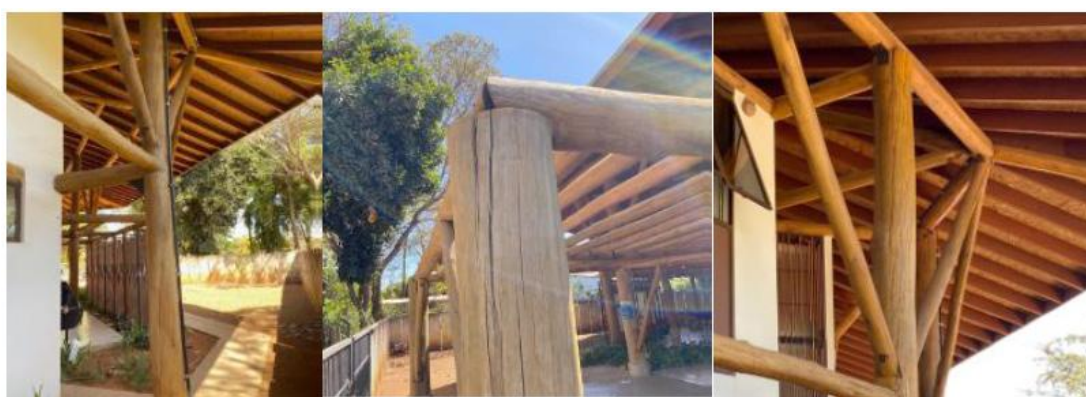
Figure 3 shows photos of some of the columns of the Maloca taken during the inspection.

**Figure 3:** Photos taken of the Maloca's columns (Laboratório de Reabilitação do Ambiente Construído 2022).

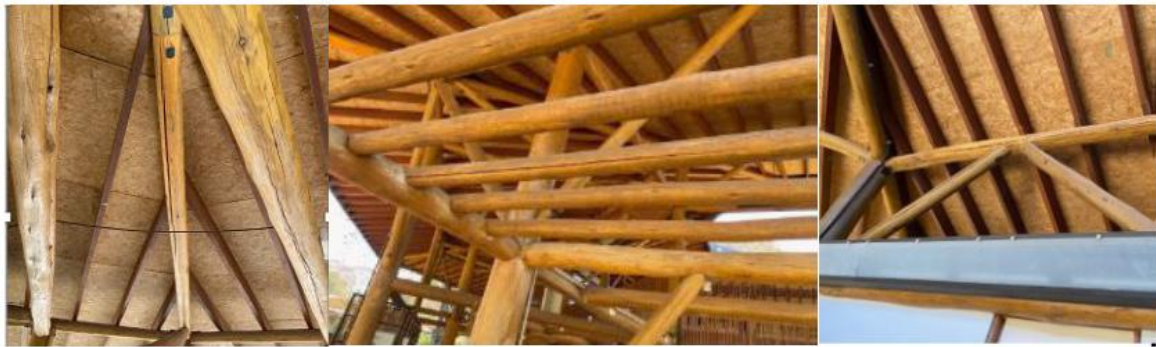
Figure 6 shows photos of some of the beams of the Maloca taken during the inspection.

**Figure 6:** Photos taken of the Maloca's beams (Laboratório de Reabilitação do Ambiente Construído 2022).
